# Fergus and Judith Basin Counties Remaining Prospects

Final Report  
Abandoned Mine Reclamation Project

## FERGUS AND JUDITH BASIN COUNTIES REMAINING PROSPECTS ABANDONED MINE RECLAMATION PROJECT

Robert Peccia & Associates, Inc.  
Helena, MT

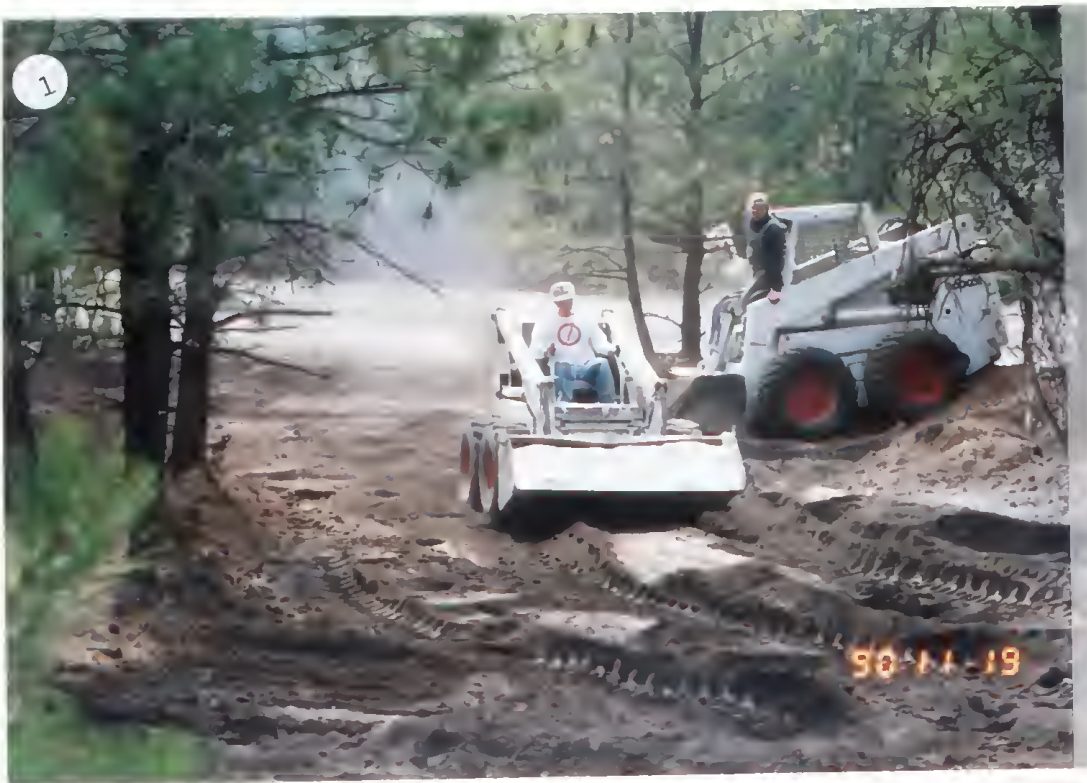
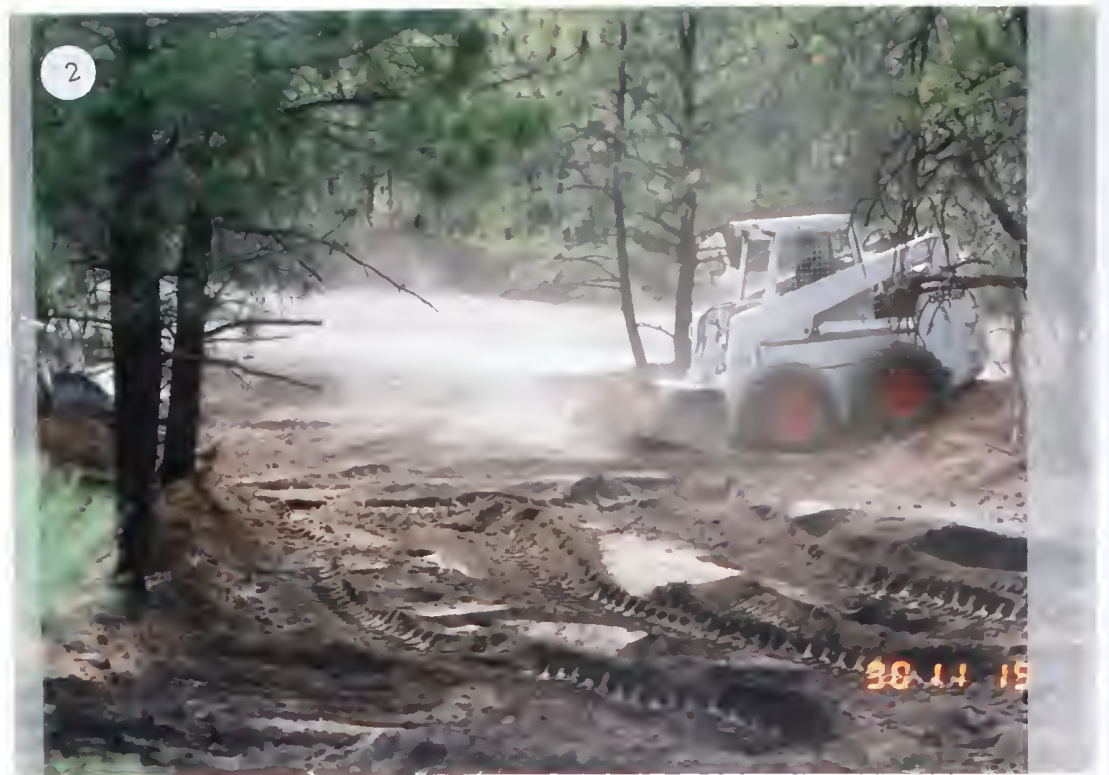
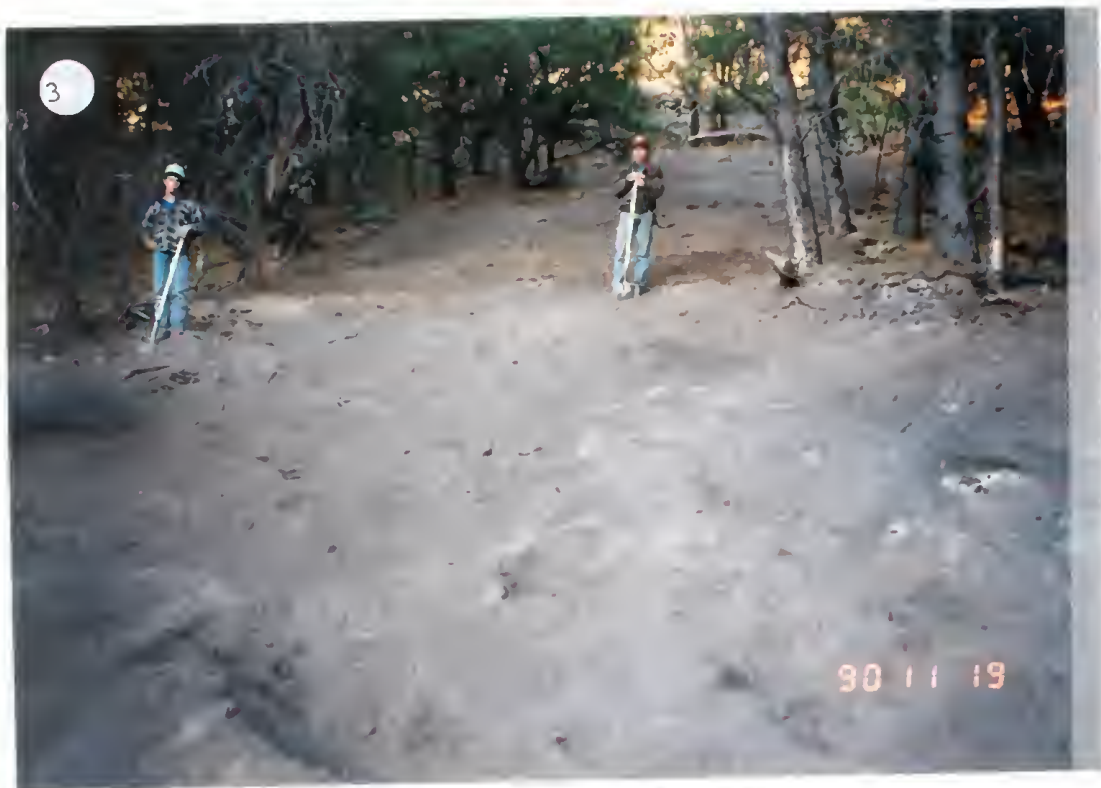
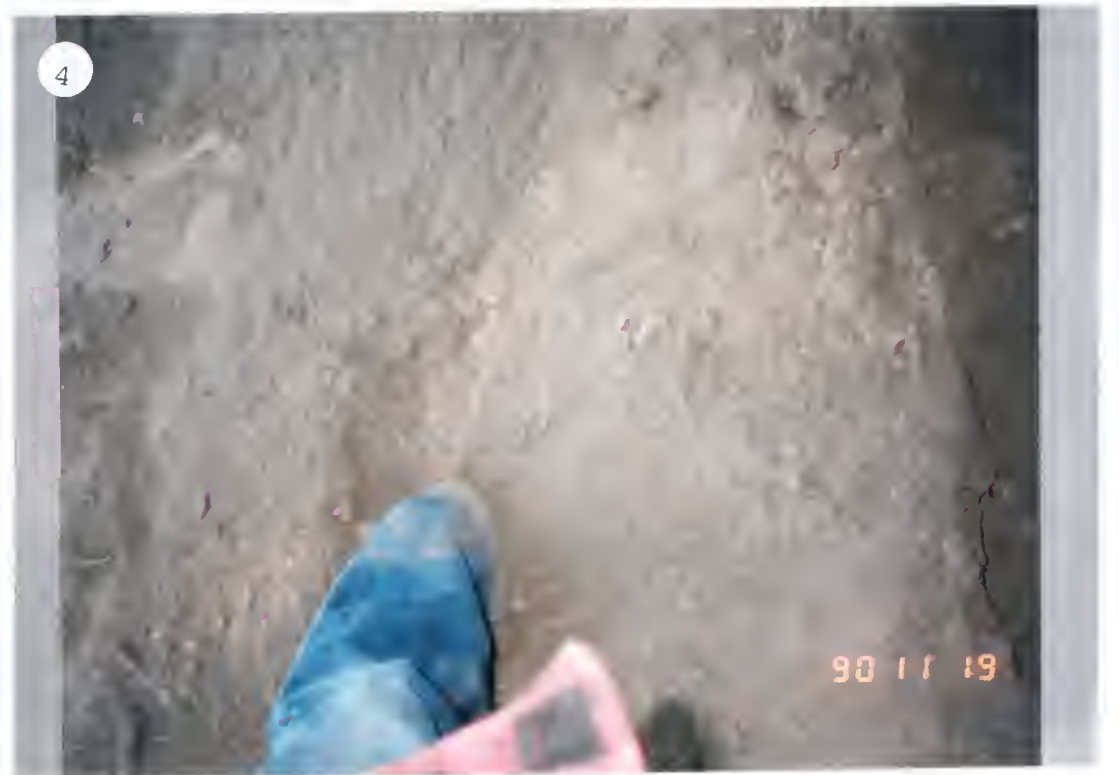
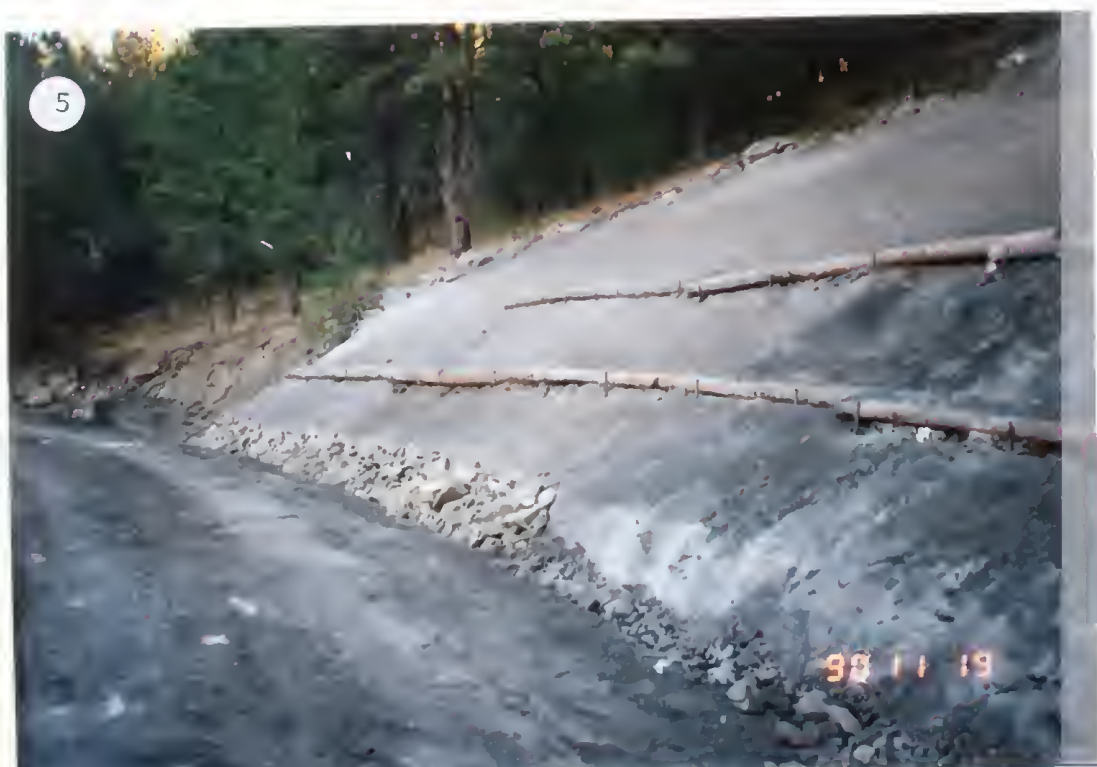
1. Swanson/Boyce - Lime Incorporation at North Site
2. Swanson/Boyce - Stripping Coversoil at North Site to Re-lime
3. Swanson/Boyce - Lime Incorporation
4. Swanson/Boyce - Spoils Condition
5. Swanson/Boyce - Limed Spoils at South Site

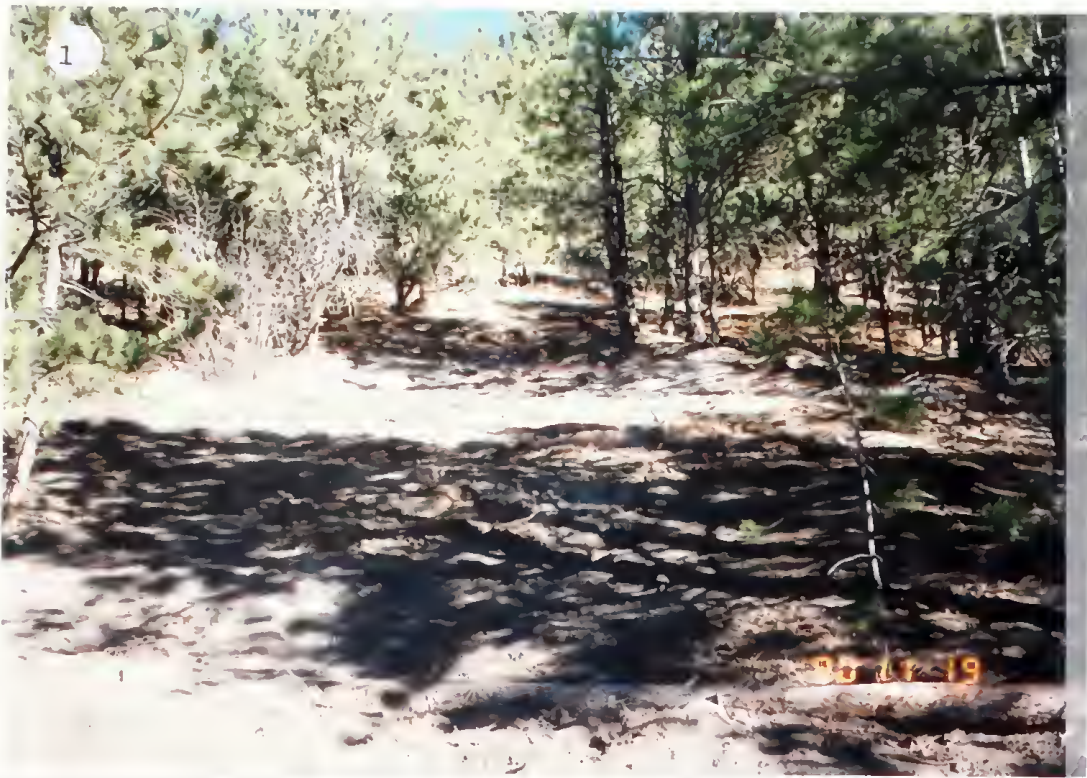
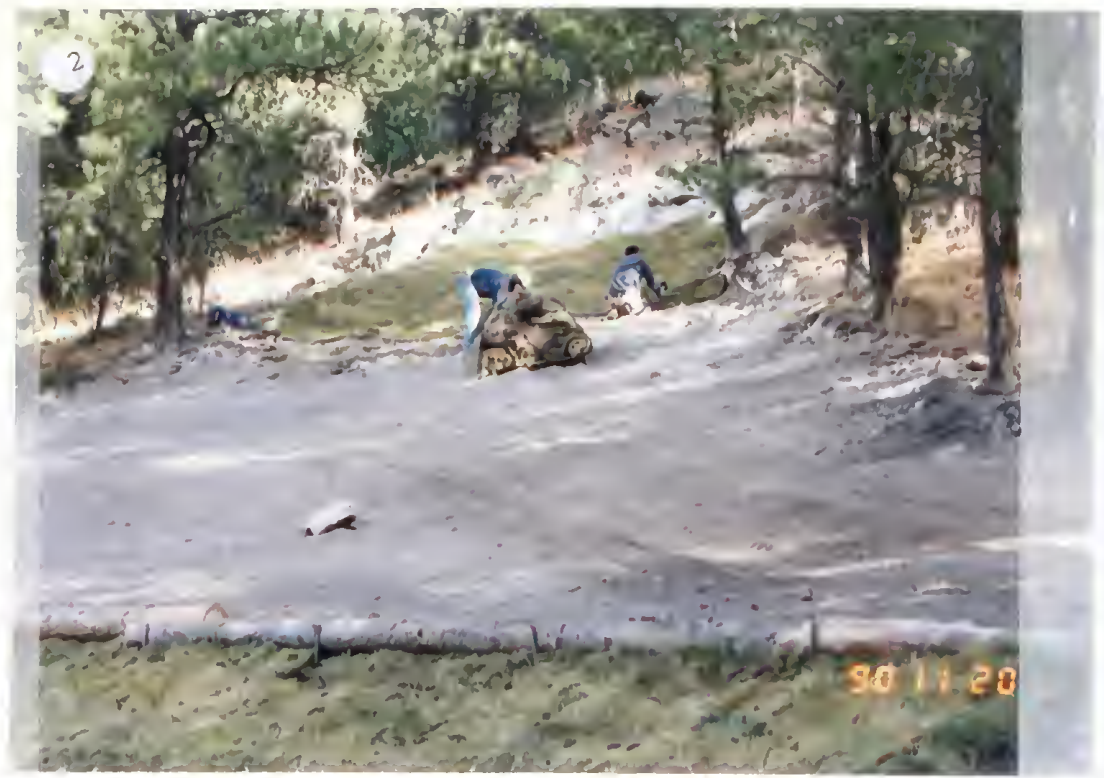
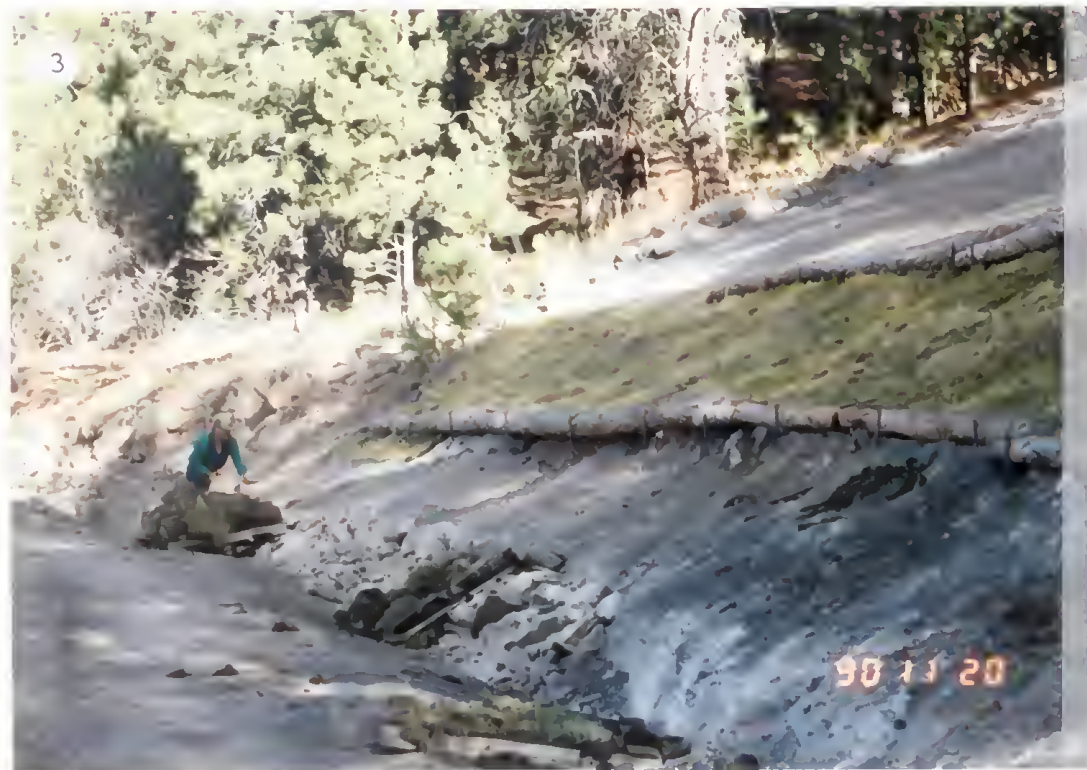
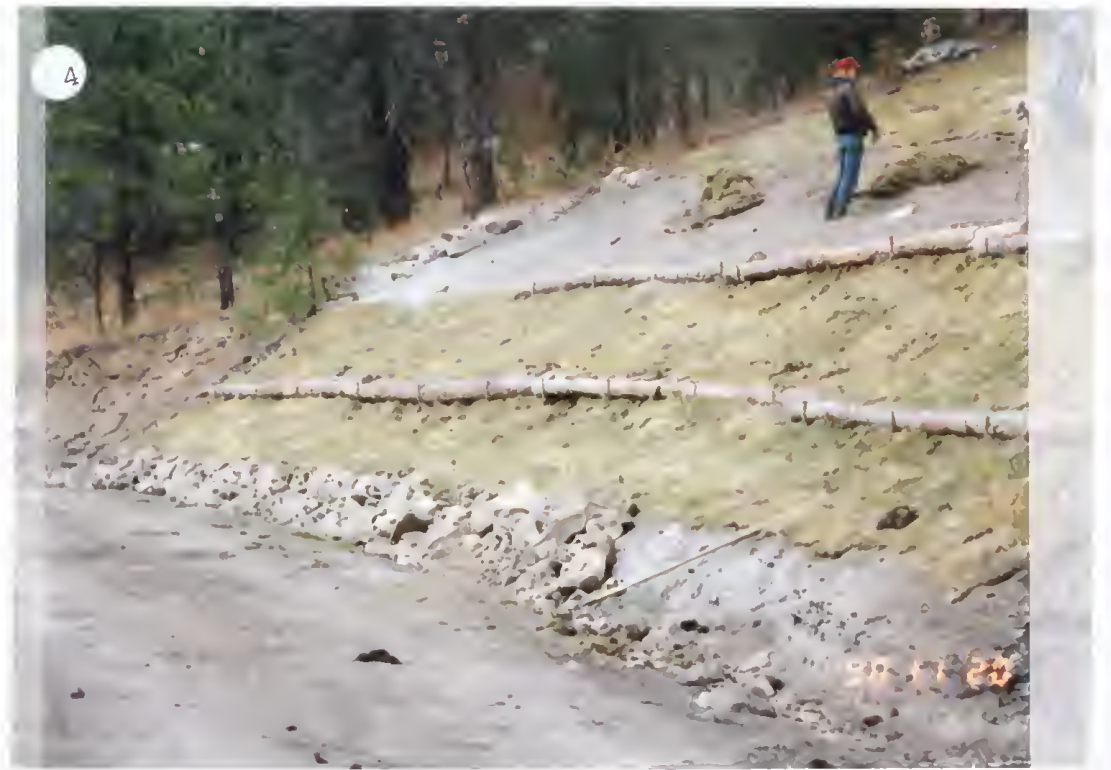
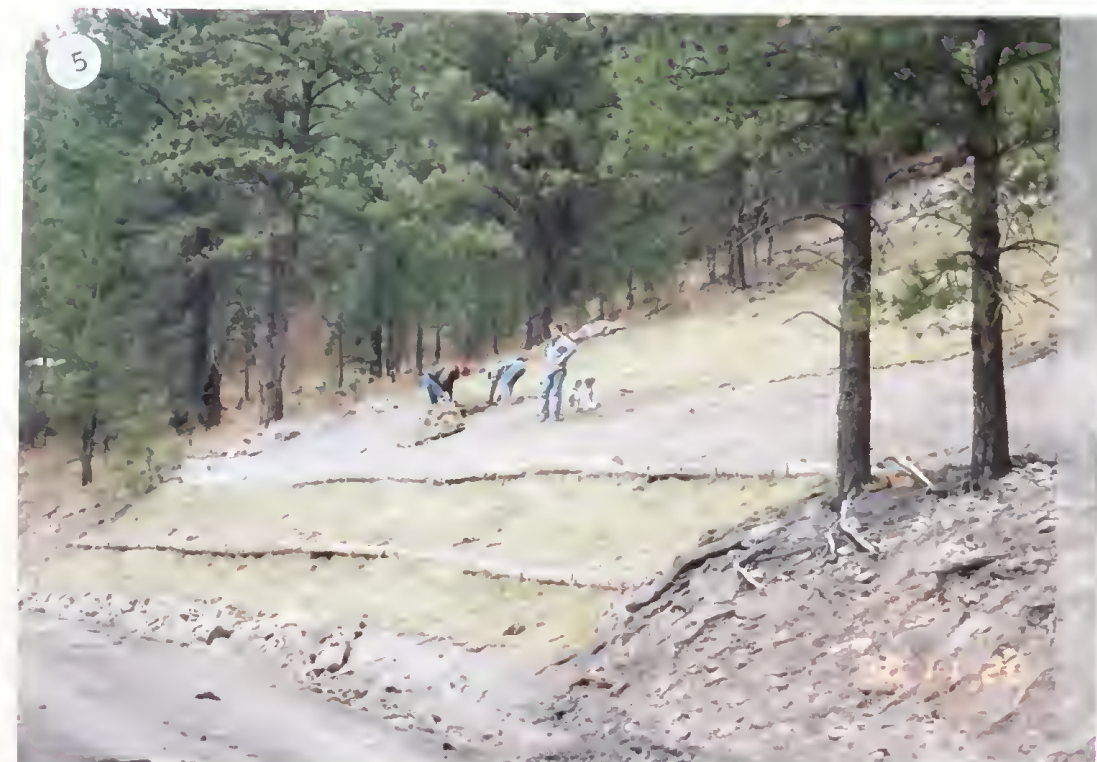
1. Swanson/Boyce - Coversoil Borrow Area
2. Swanson/Boyce - Regraded Coversoil Borrow Area
3. Swanson/Boyce - Road Signs
4. Swanson/Boyce - Coversoil Borrow
5. Swanson/Boyce - Coversoil Spread at North Site

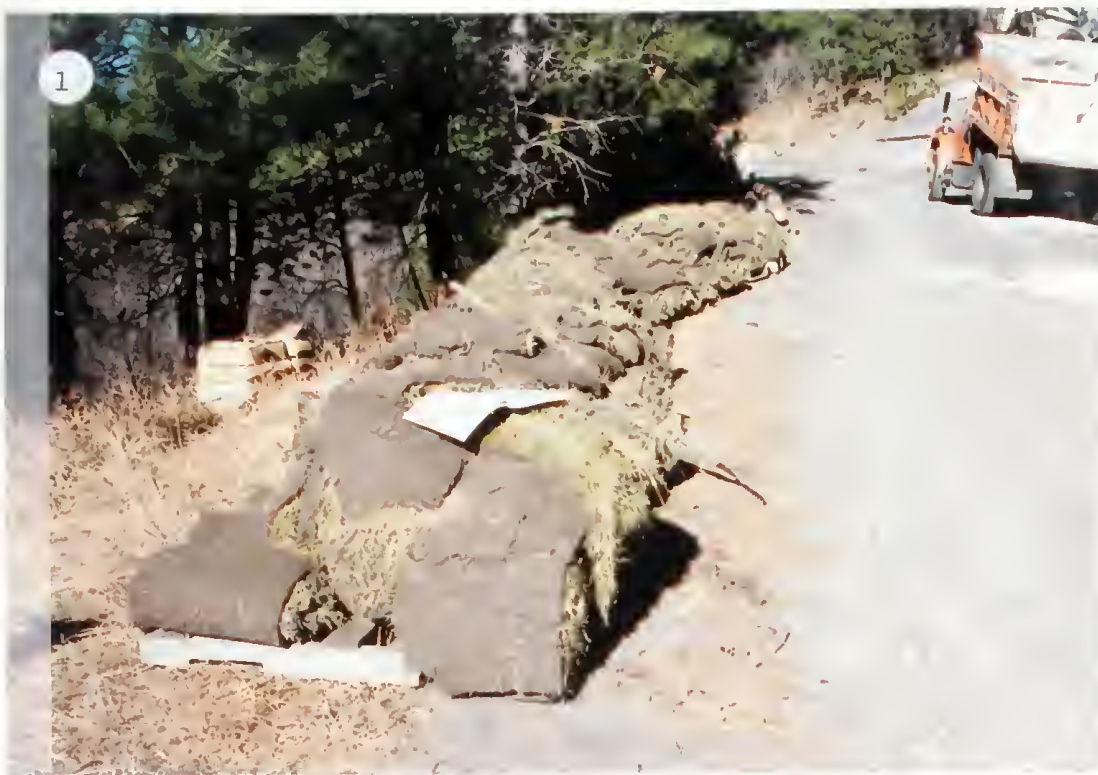
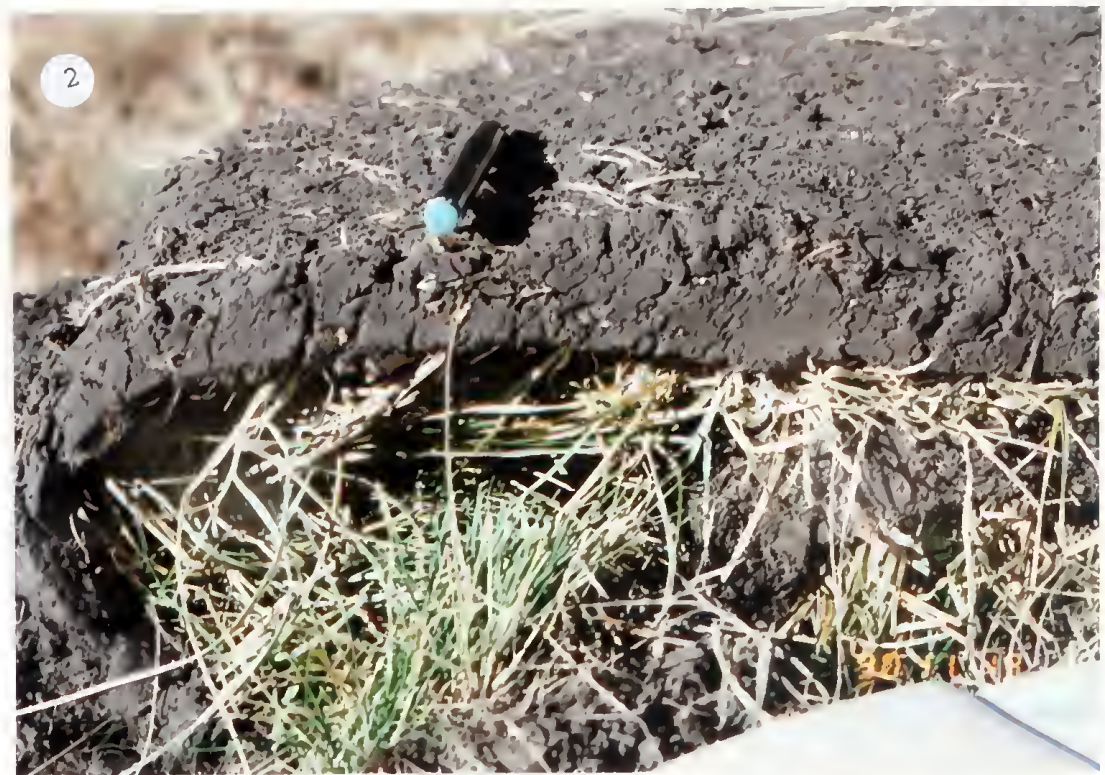
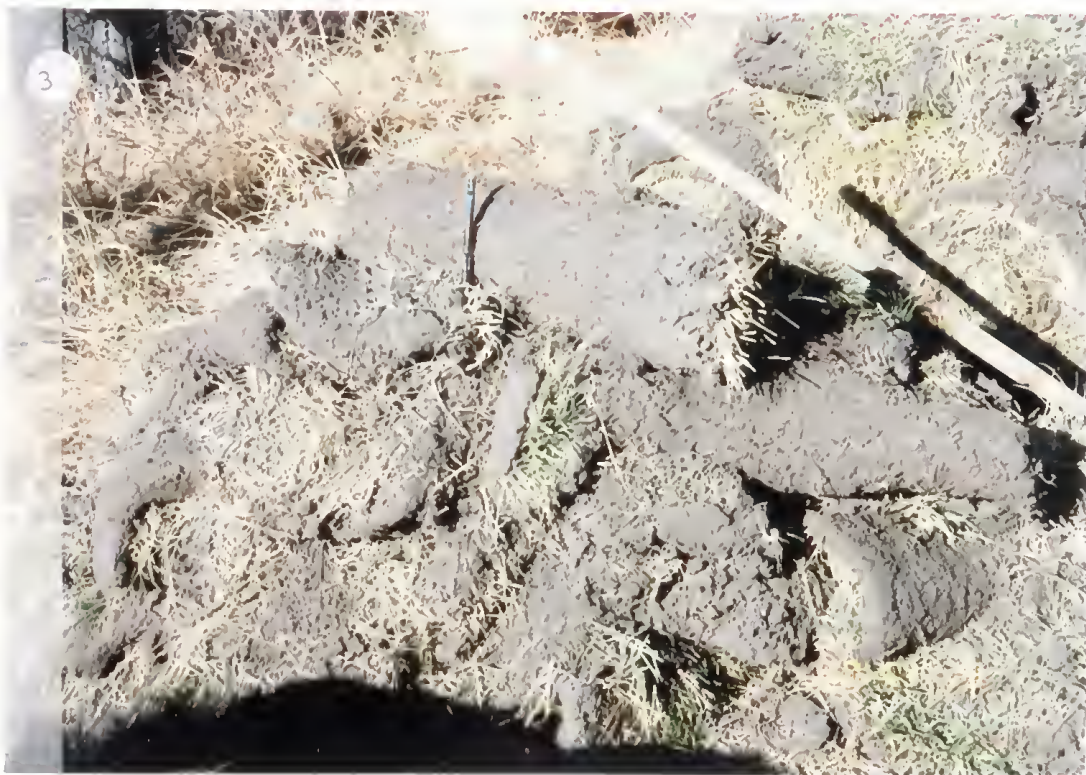
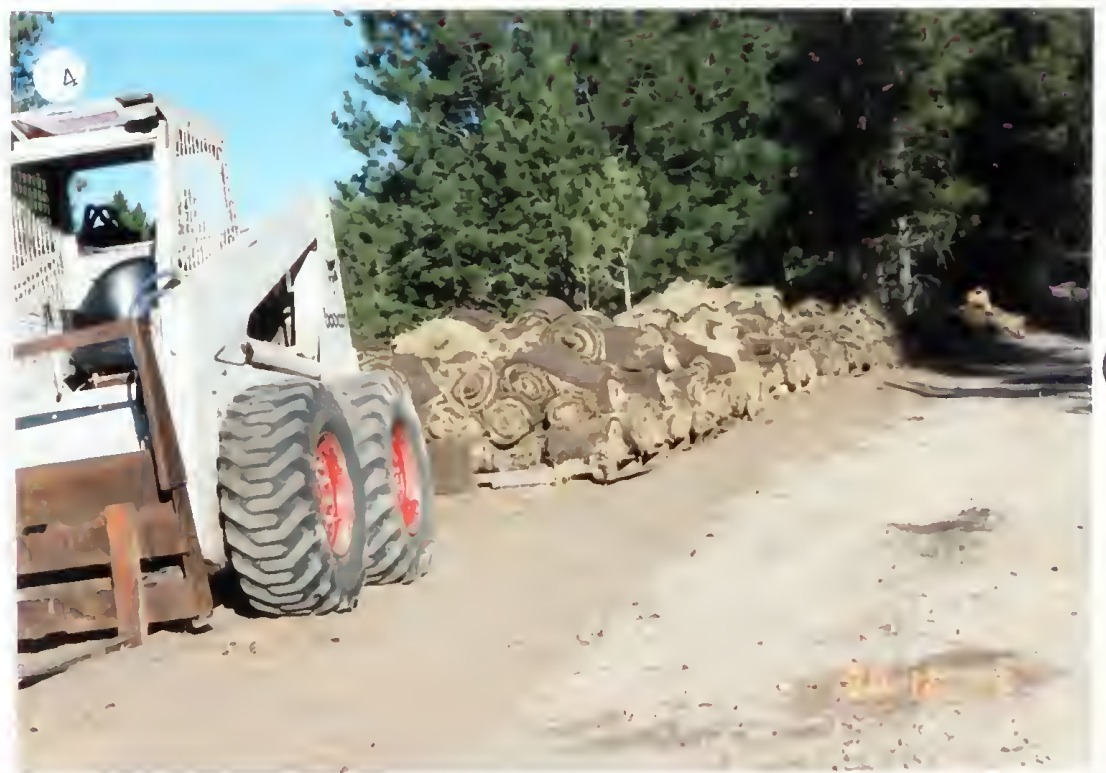
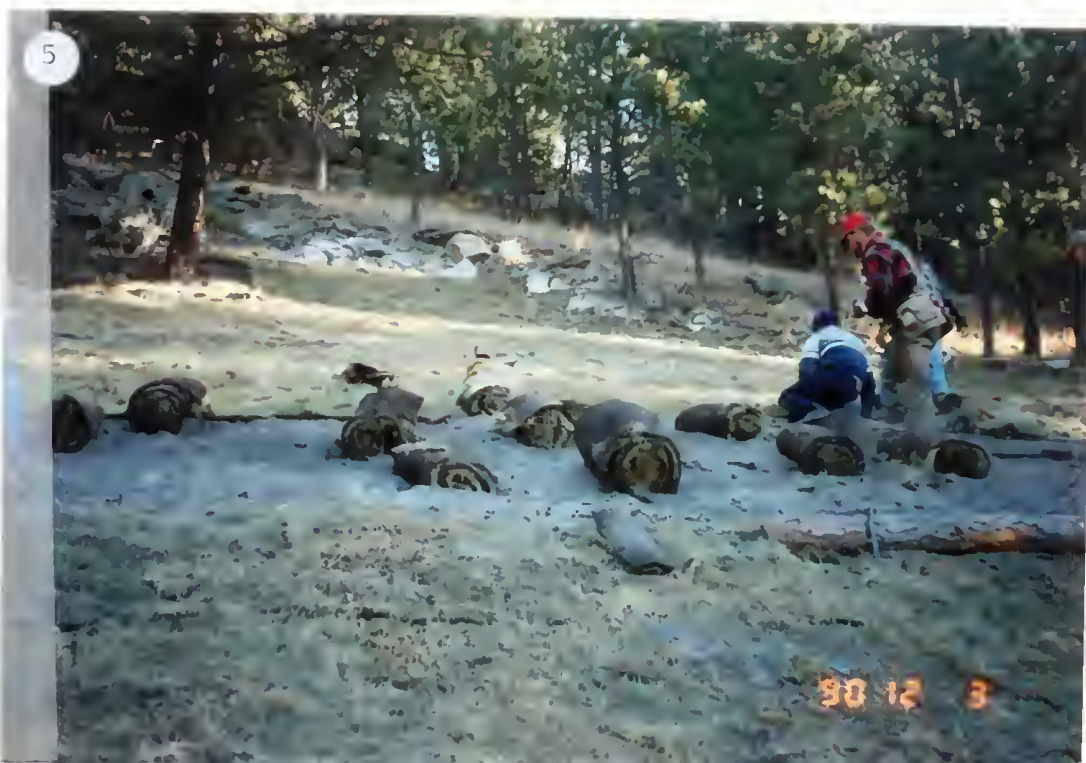
1. Swanson/Boyce - Sod "Thickspike Wheatgrass"
2. Swanson/Boyce - Sod thickness
3. Swanson/Boyce - Broken Sod Rolls
4. Swanson/Boyce - Sod "Thickspike Wheatgrass"
5. Swanson/Boyce - South Site Sod Placement

Some of the sod placed on the north site was frozen and broken into small pieces. This material was placed more as mulch/topsoil and did not conform to the initial design concept.

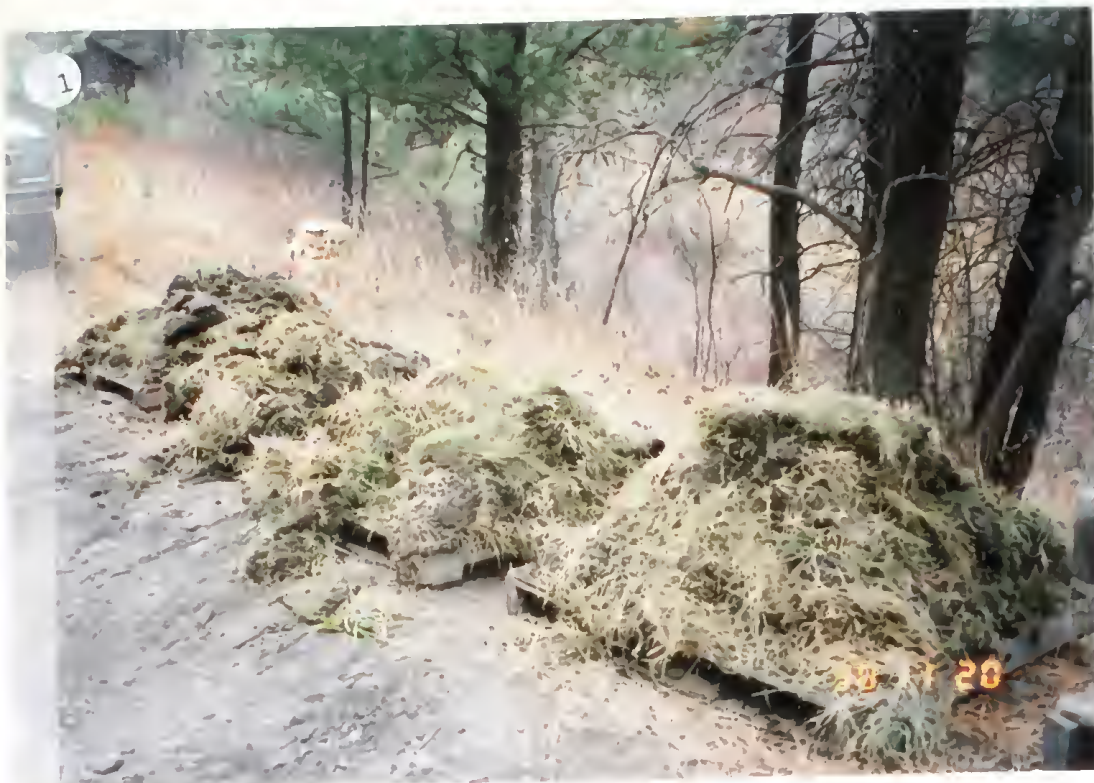
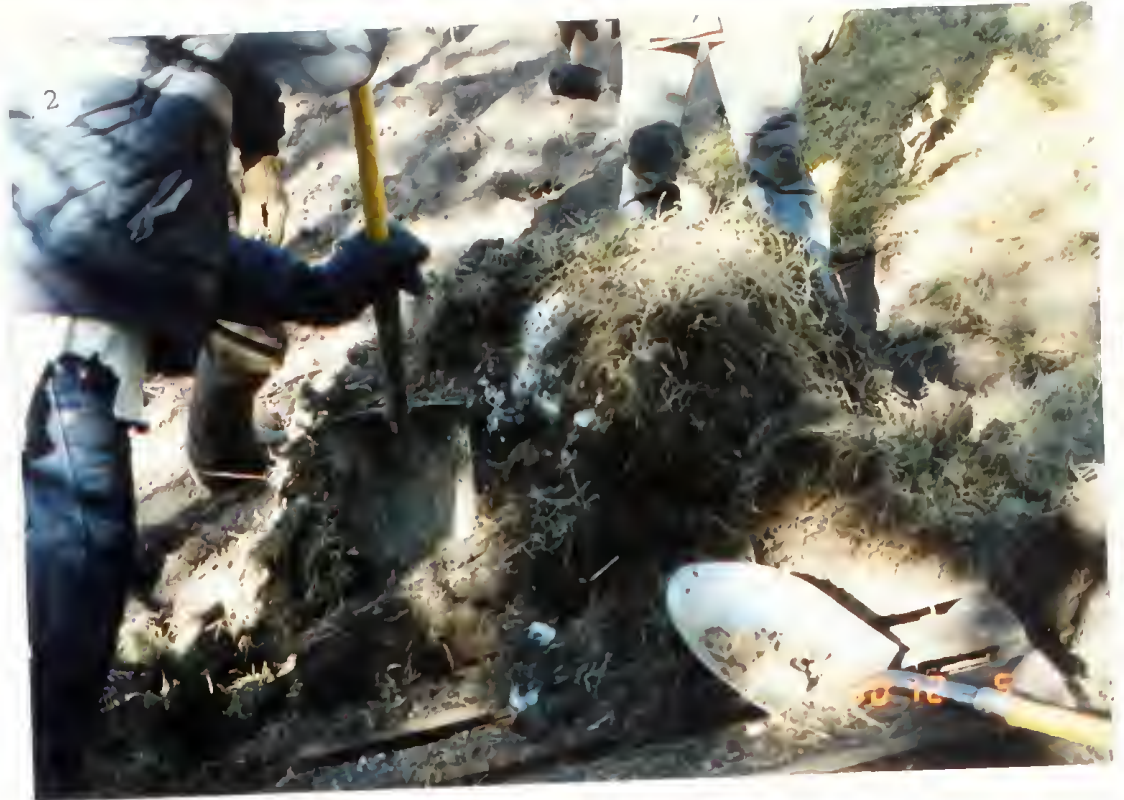
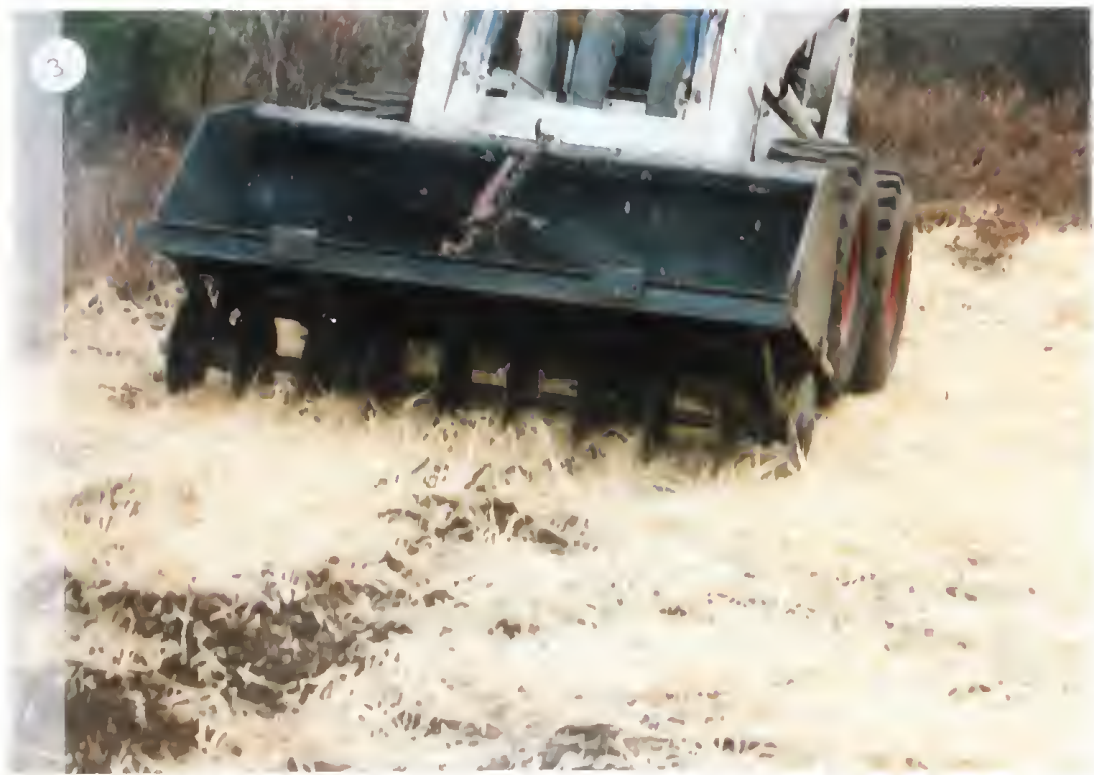
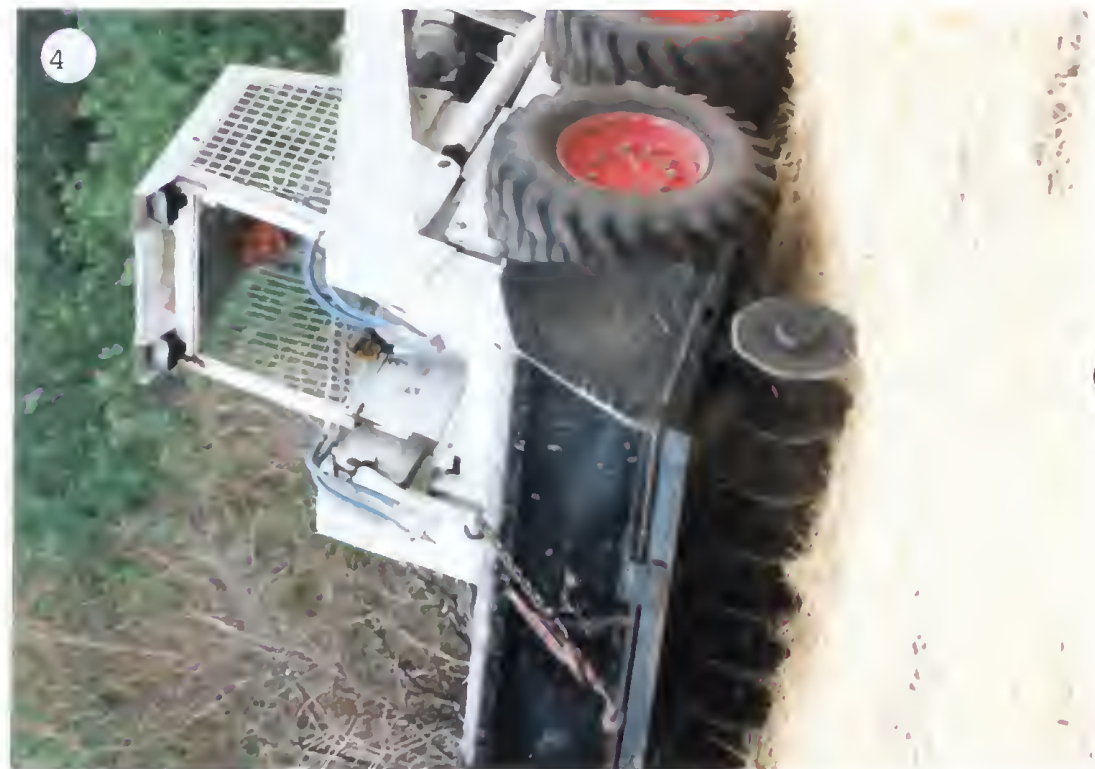
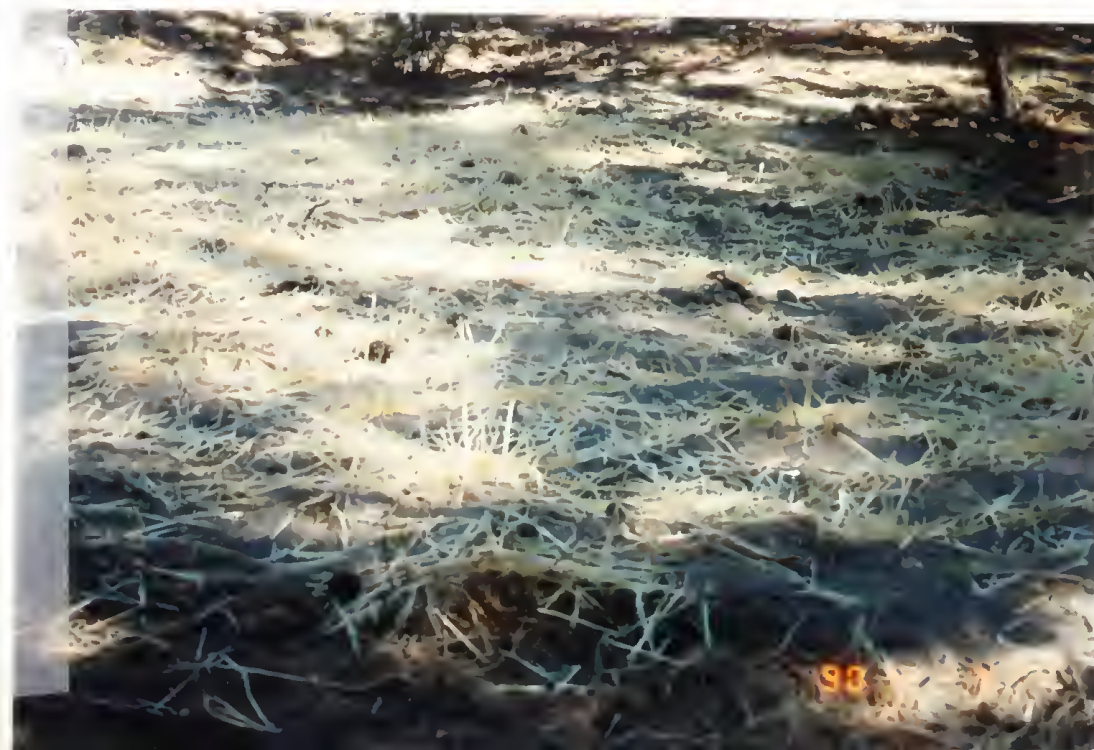
1. Swanson/Boyce - Sod "Sheep Fescue"
2. Swanson/Boyce - Sod Frozen & Broken into Small Pieces
3. Swanson/Boyce - Mulch Crimping at Coversoil Borrow Area
4. Swanson/Boyce - Mulch Crimping at Coversoil Borrow Area
5. Swanson/Boyce - Mulch Crimping on Access Road

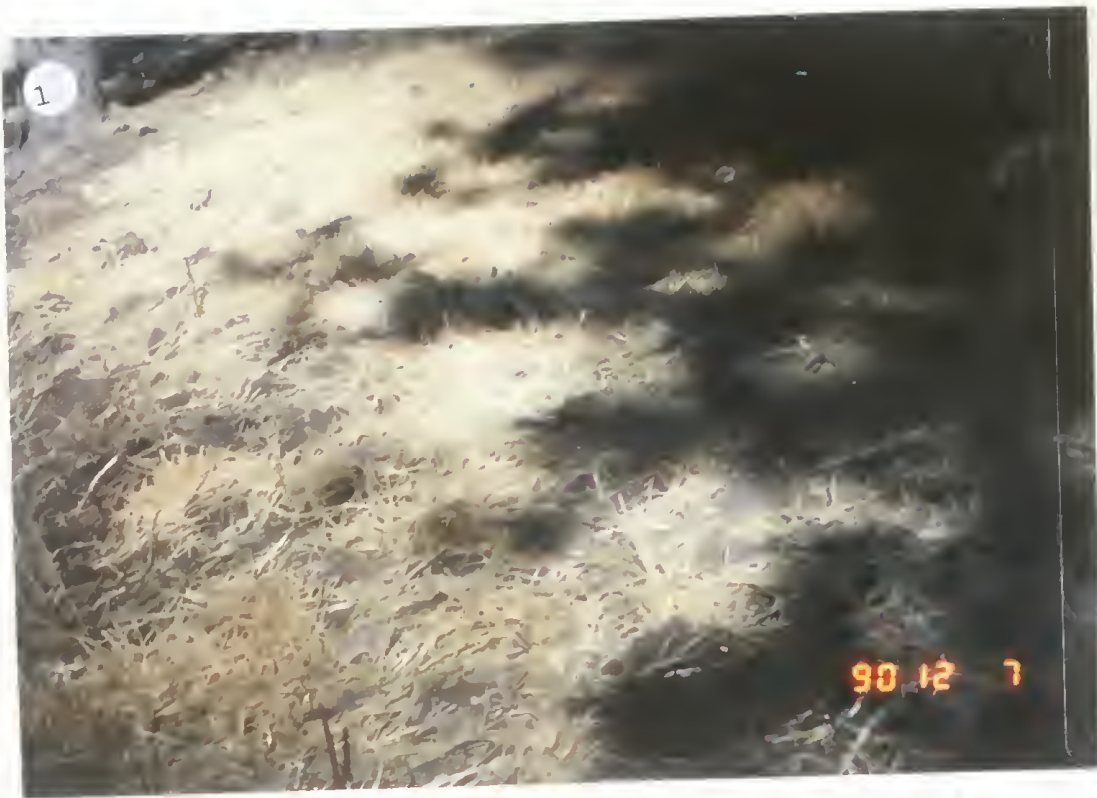
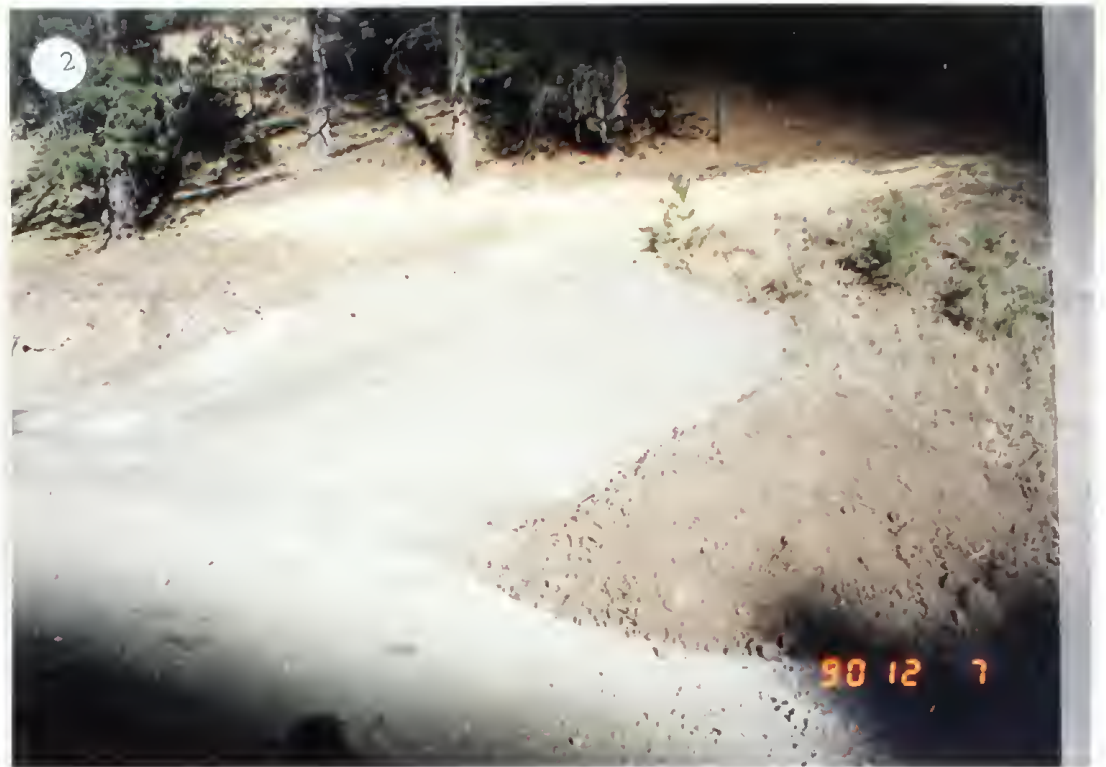
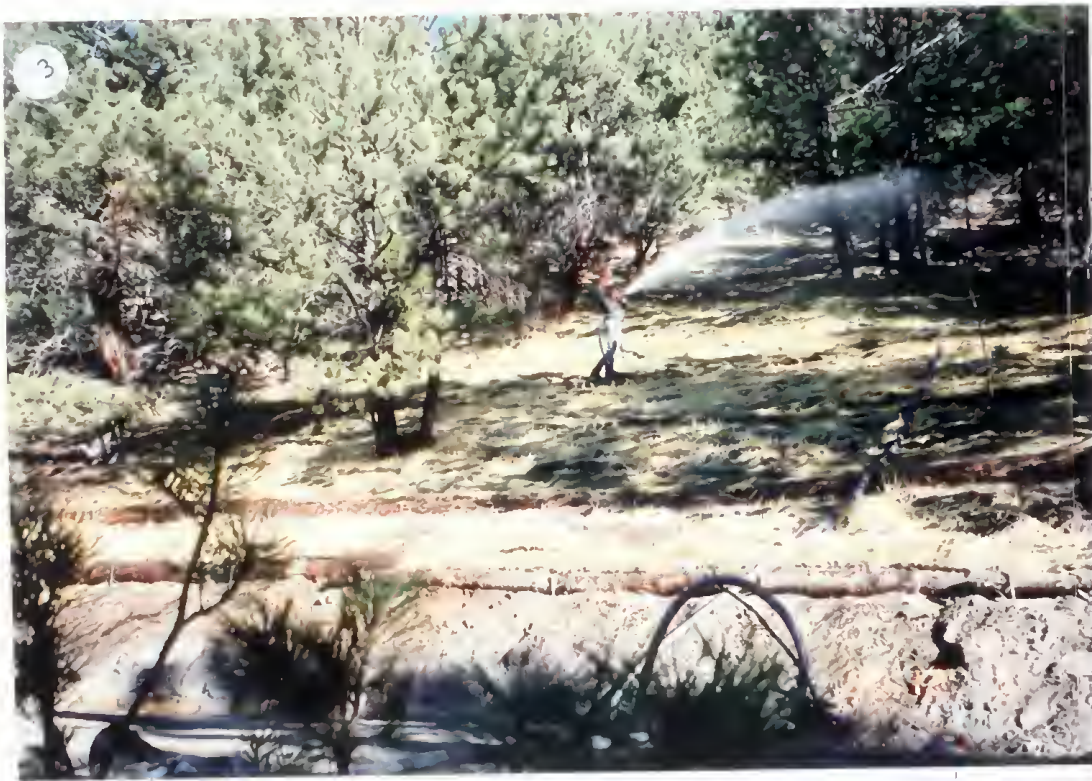
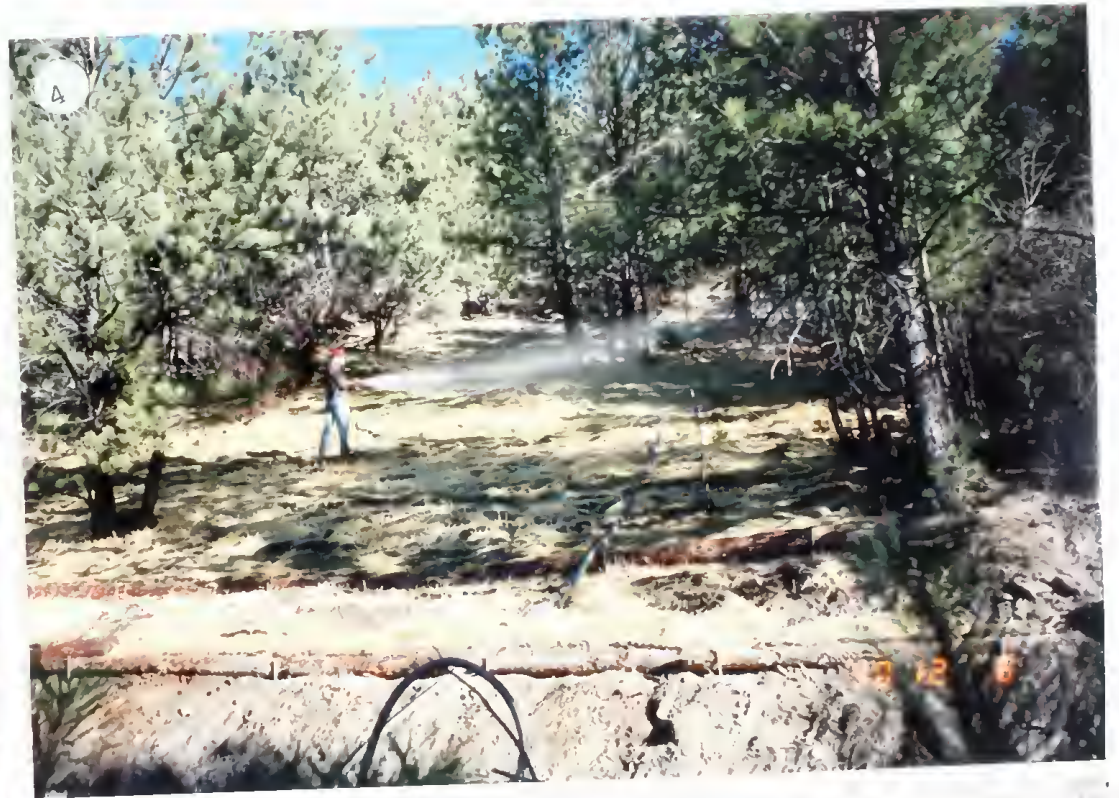
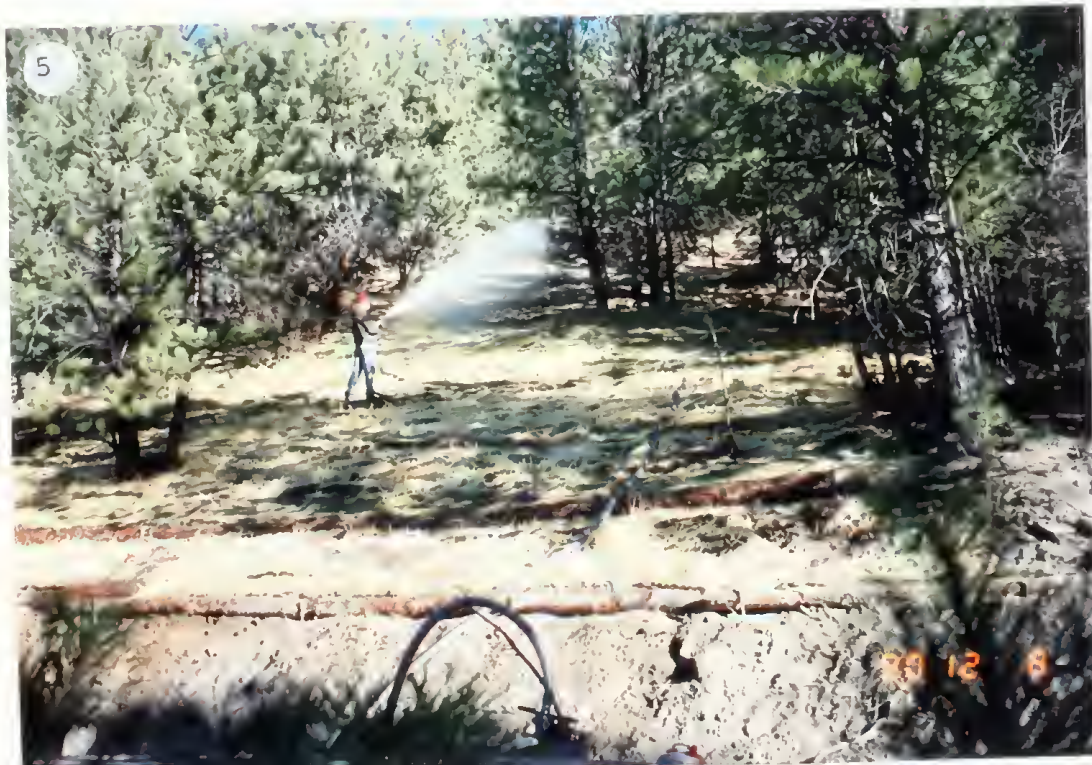
1. Swanson/Boyce - Crimped Straw Mulch at Access to South Site
2. Swanson/Boyce - Lime Incorporation at Deposition Area (also coversoil)
3. Swanson/Boyce - Water Application
4. Swanson/Boyce - Water Application
5. Swanson/Boyce - Water Application
